**PROPOSED BOAT RAMP & PONTON JETTY**

**LAKE TYERS ABORIGINAL TRUST**

**INTERPRETIVE GEOTECHNICAL INVESTIGATION**

**REPORT NO V2367R1, APRIL 2025**

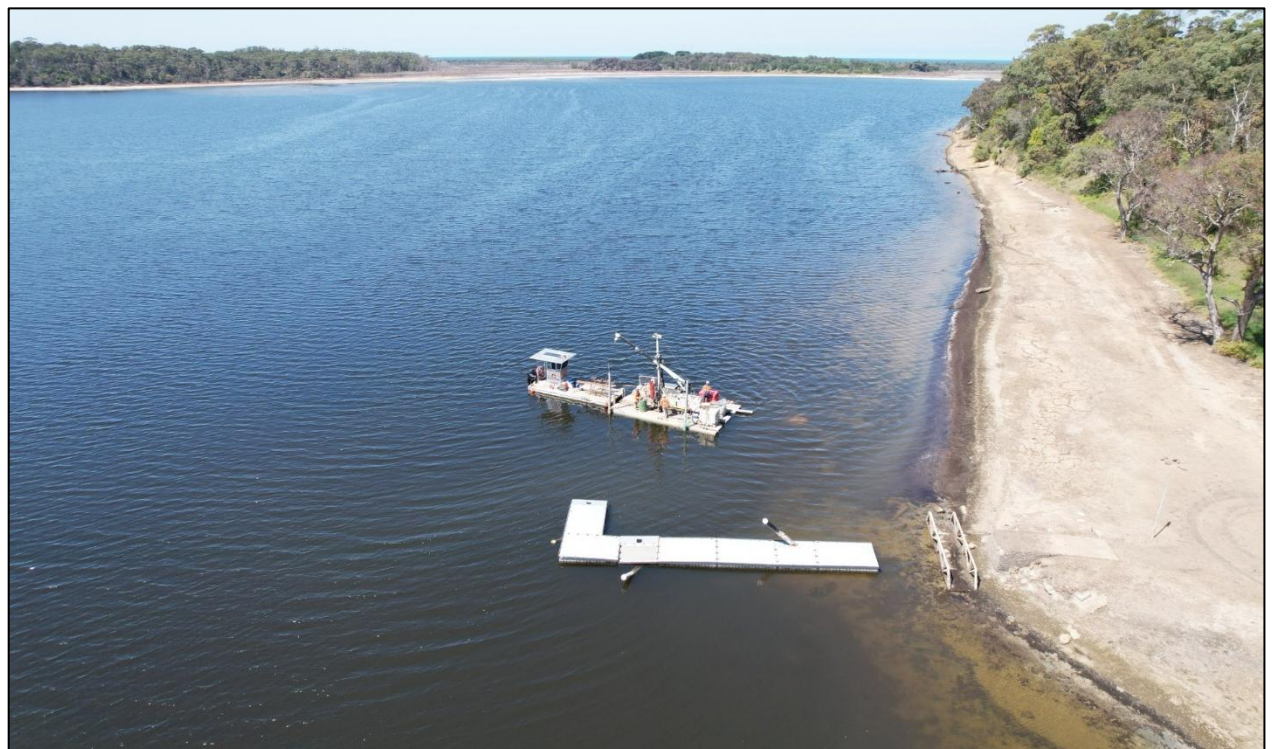
Image 3. The existing jetty at LTAT shown in the foreground.

The existing pontoon jetty has a plastic plank deck, supported on timber piles that are tilting considerably. The condition of the piles below the water are assumed to be in poor condition, and the whole jetty is structurally dilapidated. A photo of the existing pontoon is shown below in Image 3.

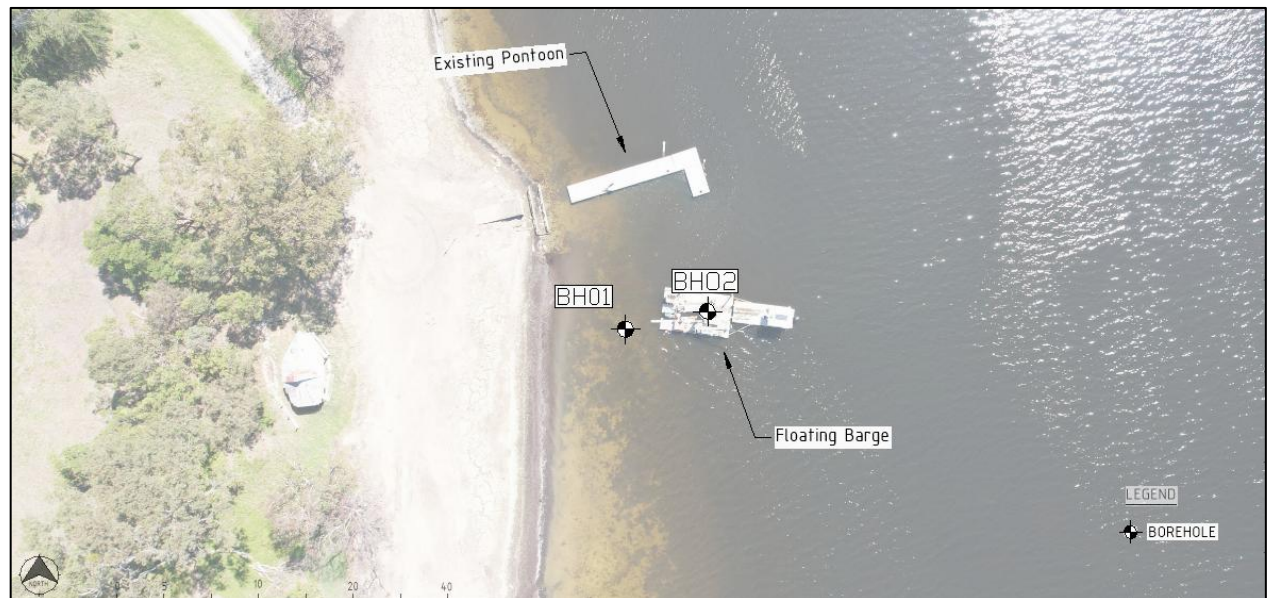
Image 5. Aerial image illustrating the borehole locations at Lake Tyers.

To assess the site sub-surface conditions, two rotary drill wash-bore boreholes were drilled from the lake surface on a floating barge to a maximum depth of 17.4 m below lake surface level. The drill rig was provided by Star Drilling and the barge was provided by Carter Marine.

The borehole locations were recorded using a high-accuracy RTK GPS.

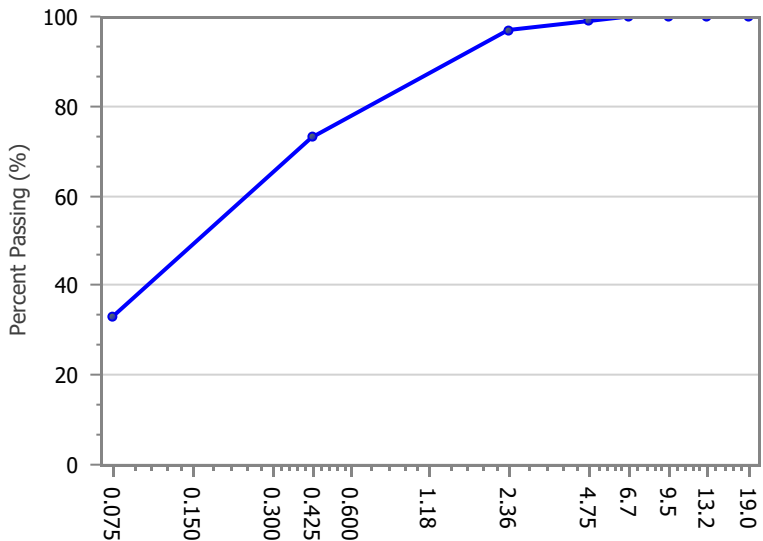
**PARTICLE SIZE DISTRIBUTION GRAPH**

AS Sieve (mm)	Specification Minimum (%)	Percent Passing (%)	Specification Maximum (%)
19.0		100	
13.2		100	
9.5		100	
6.7		100	
4.75		99	
2.36		97	
0.425		73	
0.075		33

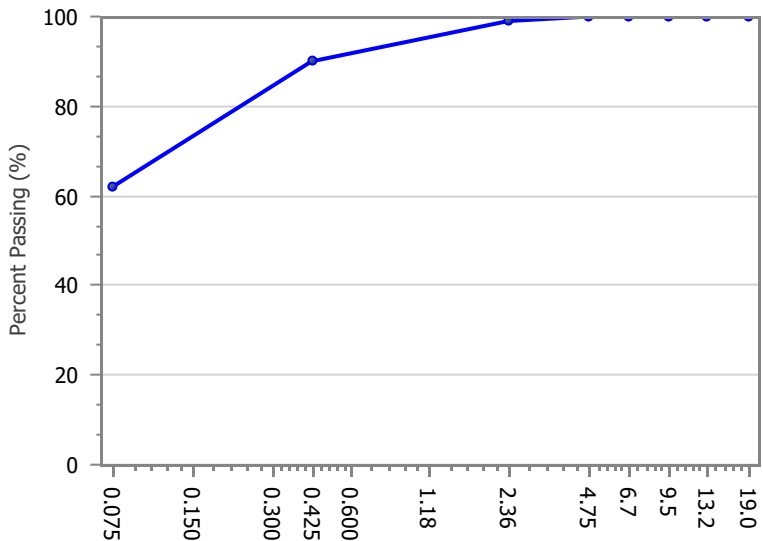
**PARTICLE SIZE DISTRIBUTION GRAPH**

AS Sieve (mm)	Specification Minimum (%)	Percent Passing (%)	Specification Maximum (%)
19.0		100	
13.2		100	
9.5		100	
6.7		100	
4.75		100	
2.36		99	
0.425		90	
0.075		62

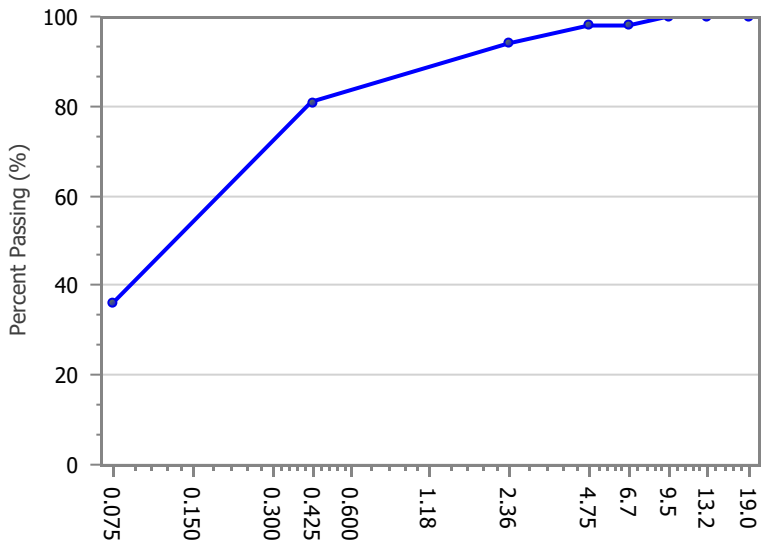
**PARTICLE SIZE DISTRIBUTION GRAPH**

AS Sieve (mm)	Specification Minimum (%)	Percent Passing (%)	Specification Maximum (%)
19.0		100	
13.2		100	
9.5		100	
6.7		98	
4.75		98	
2.36		94	
0.425		81	
0.075		36

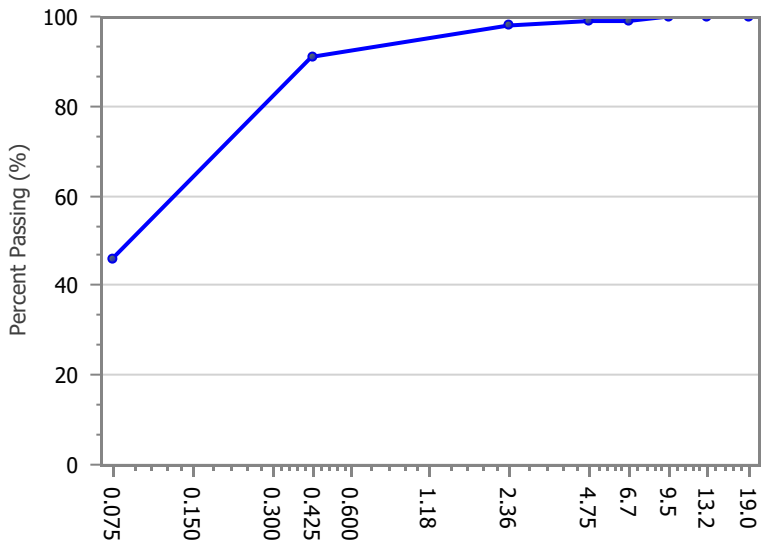
**PARTICLE SIZE DISTRIBUTION GRAPH**

AS Sieve (mm)	Specification Minimum (%)	Percent Passing (%)	Specification Maximum (%)
19.0		100	
13.2		100	
9.5		100	
6.7		99	
4.75		99	
2.36		98	
0.425		91	
0.075		46
