## GEOTECHNICAL INVESTIGATION REPORT

**PROJECT:** SEAGULL DRIVE BOAT RAMP, LOCH SPORT

**CLIENT:** BMT COMMERCIAL AUSTRALIA Pty Ltd

**REPORT No.:** GE13574-23

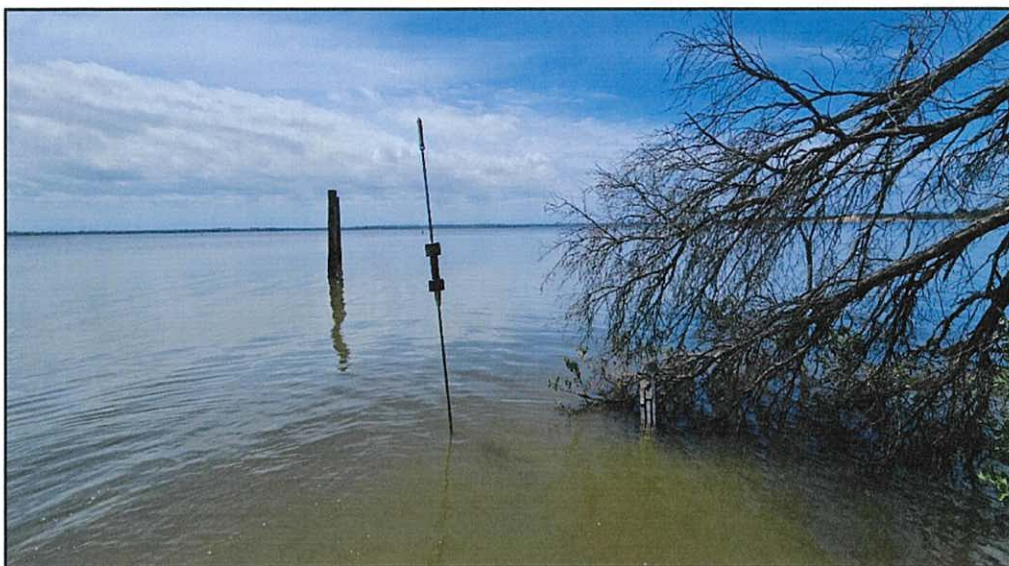
DCP3 testing location; looking at east
